THE YALE GOLF COURSE TREE MANAGEMENT PLAN

Bradley R. Painter

T R E E F O I L
CONSULTING ARBORISTS

June 12, 2024

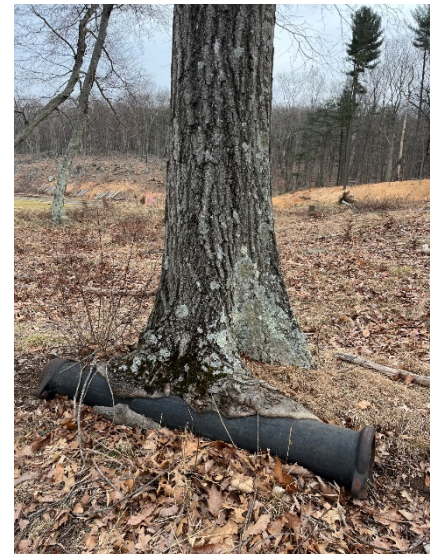
Figure 19 Tree Base Growing Around Original 1920's Irrigation Piping

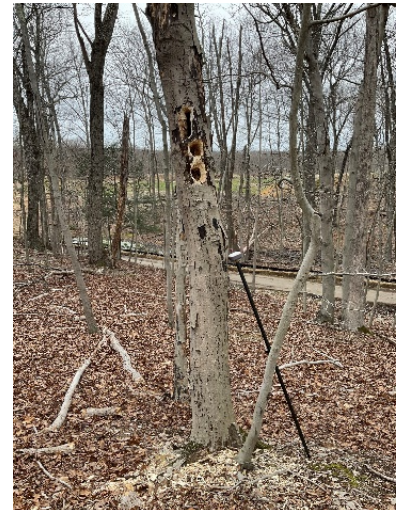
Figure 23 Standing Deadwood Habitat (w/leaning GPS Pole)

opportunities with numerous decaying or dead trees with nesting cavities throughout the interior woodlands and the bordering Yale Nature Preserve.

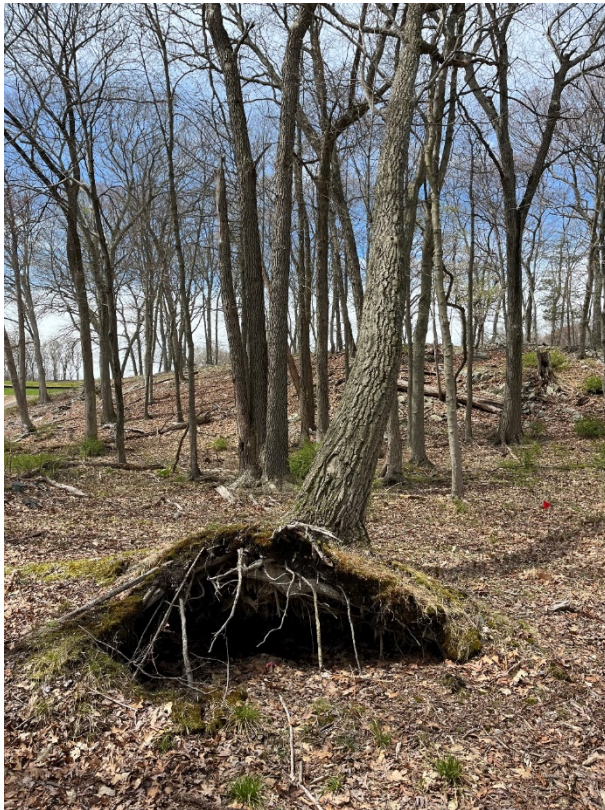
Trees that grew within groups of trees are now exposed to more frequent and stronger forces than accustomed to leading to an increased probability of partial or full failure. The trees will now be closer to the field of play. The managers should have an elevated awareness of this dynamic when scheduling tree inspections. Tree inspections and pruning cycles should focus on all forest and woodland borders to try and identify trees with hazardous architecture tendencies.

Figure 69 Tree Uprooted in Interior Woodland

Trees that are potential risks should be identified through regular scheduled monitoring and felled as the edge dynamic evolves. Cut trees can remain on the ground within woodlands and forested areas to provide habitat and reduce carbon emissions.

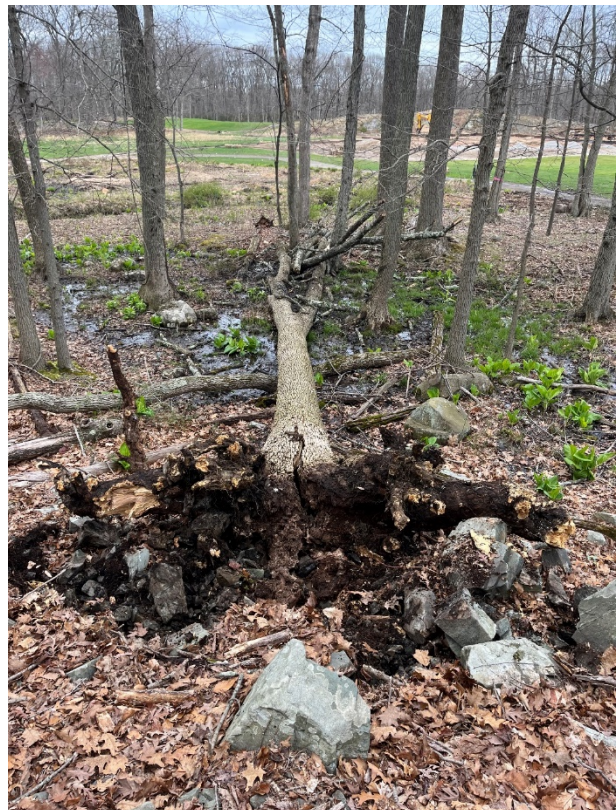
Figure 70 Basal Tree Root Fail in Interior Woodland

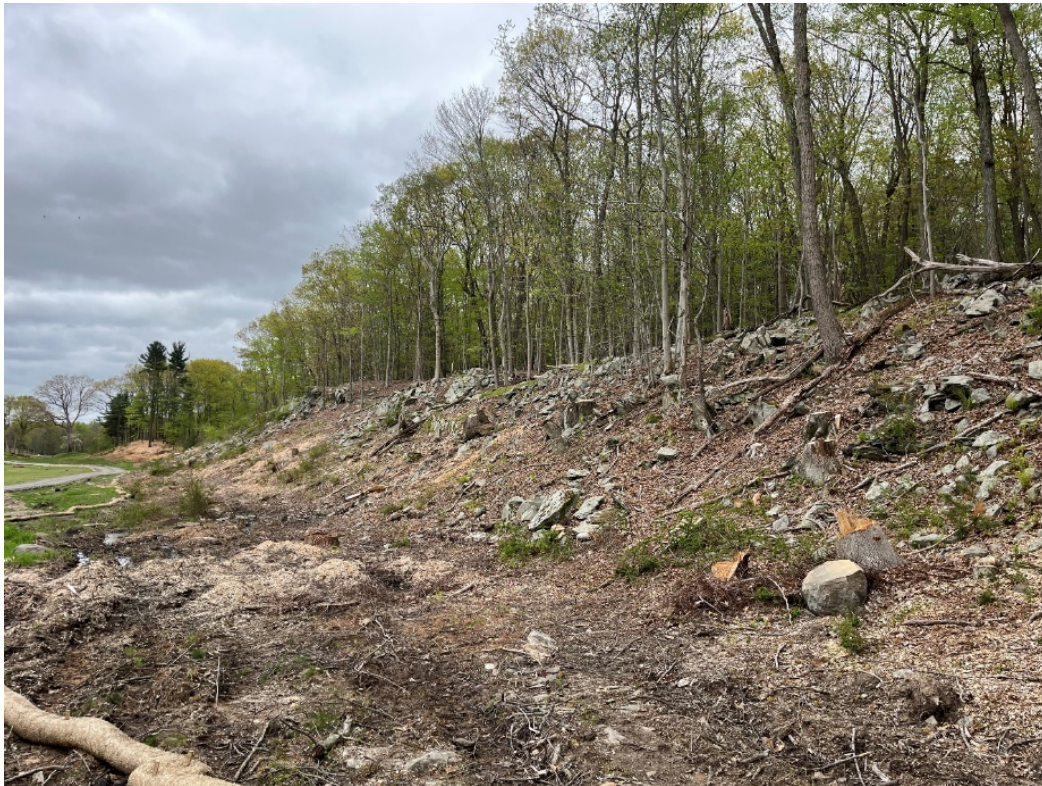
Figure 84 Cleared Areas Are Highly Prone to Invasive Species

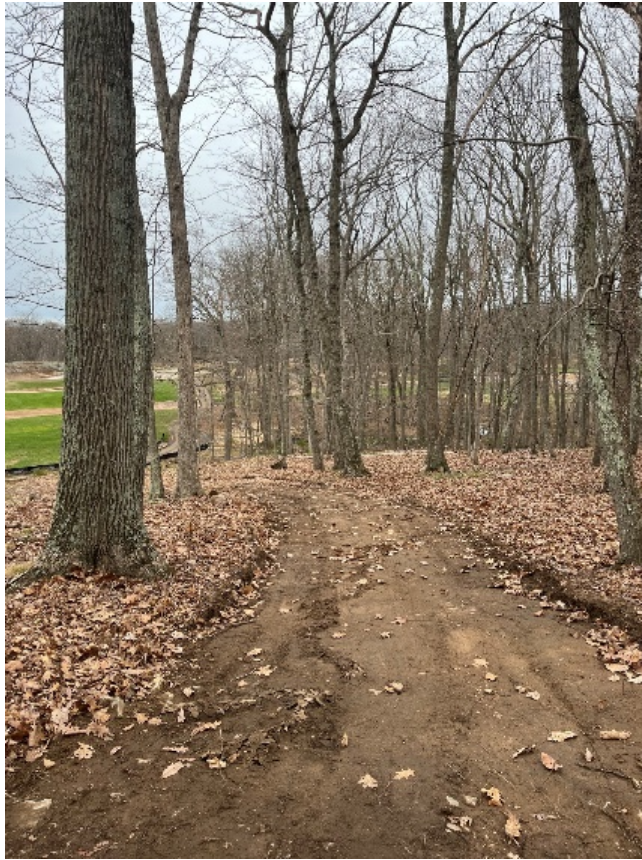
Figure 90 New Cartway Within CRZ

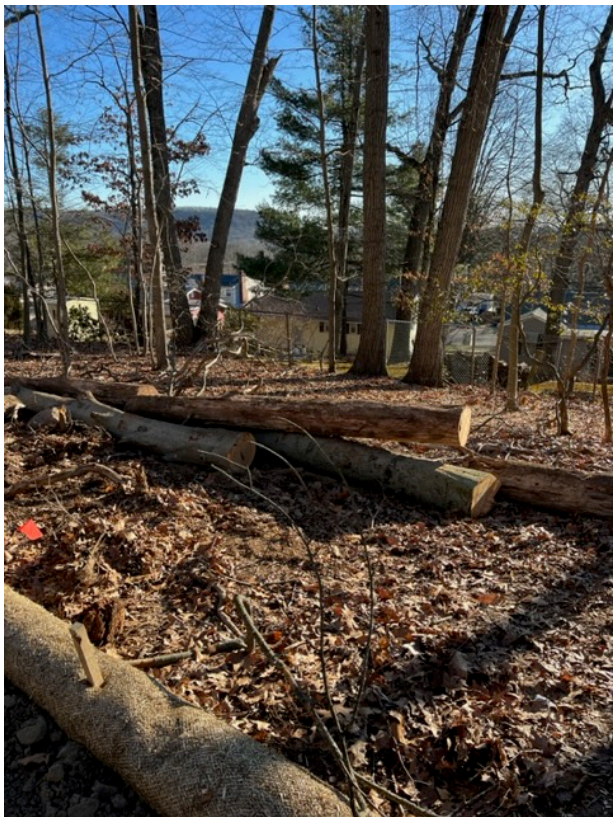
Figure 14 Felled removal trees to remain

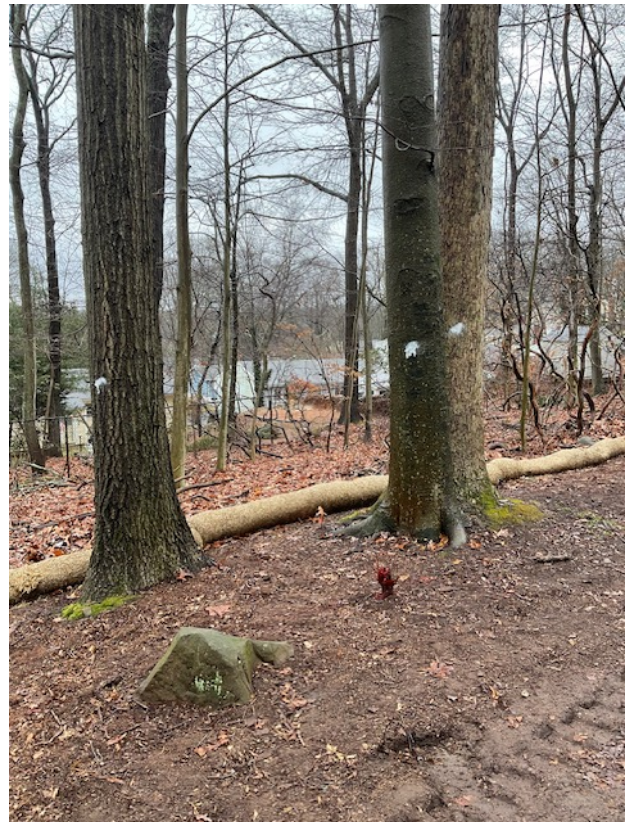
The consultants identified trees within 10' of both the east and west side haul road outside borders and evaluated them for preservation. Some trees were dead or in very poor condition and spray-painted pink for removal. Trees for preservation were spot sprayed white and tagged with numerical brass tags and inventoried. A total of 71 trees were identified for preservation adjacent to the haul road.

Figure 15 Trees designated for preservation were marked with north side white paint for easy identification

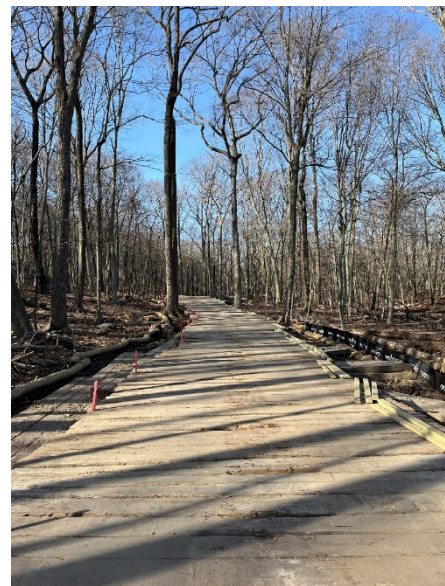
Figure 28 Photo taken mid -March after inventory work showing timber mat haul road
