THE YALE GOLF COURSE TREE MANAGEMENT PLAN

Bradley R. Painter

T R E E F O I L
CONSULTING ARBORISTS

June 12, 2024

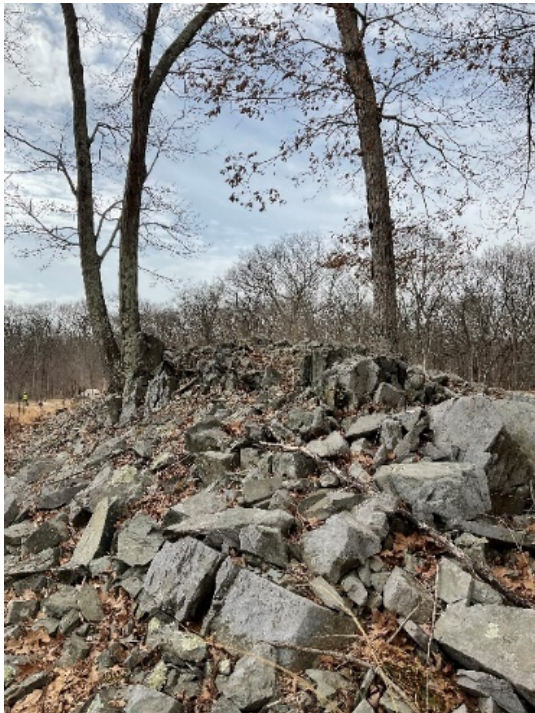
Figure 18 Typical Ledge & Rock Rubble In Interior Woodlands

Large (20" DBH plus) individual trees or smaller groups of 4 or 5 deciduous trees can be found within fairway edges and managed "rough" fairway borders. The numerous deciduous trees found within adjacent interior woodland areas and exterior golf course borders are growing in blasted rock rubble – remnants from the dynamite blasting operations performed during the original 1920's

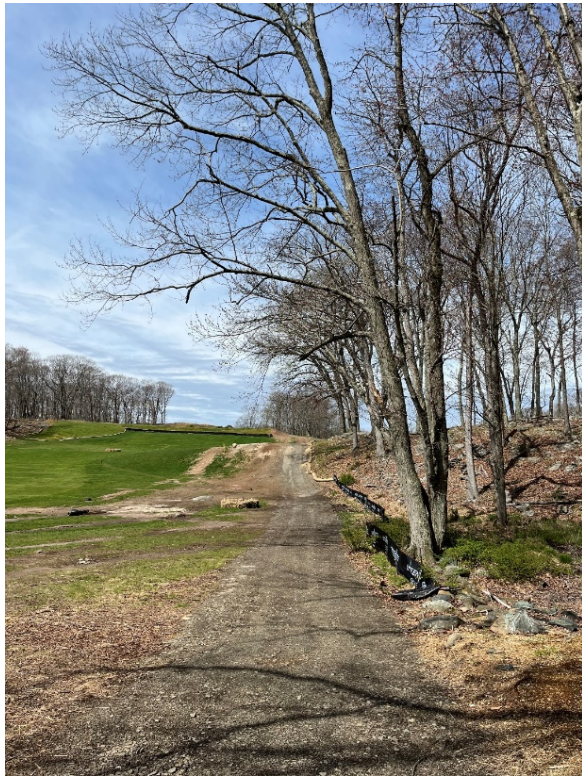
Figure 24 South Woodland Border and Cart Path 12th Hole Fairway (Thinned Area)

There are also swaths of interior woodland area ("INTERIOR TREES") varying from 10 acres and under. Some of the bordering trees of the interior woodlands and preservation border forest trees had been removed prior to/during the consultant starting/finishing the project. An unknown number of woodland and forest border trees had also been removed in prior years for various reasons such as having been in poor condition with the risk of failure, or they had started failing or had completely failed. It is also expected that the natural encroachment of the migrating woodland or forest edge into open fairway areas obstructed the field of play and flow and were consequently removed.

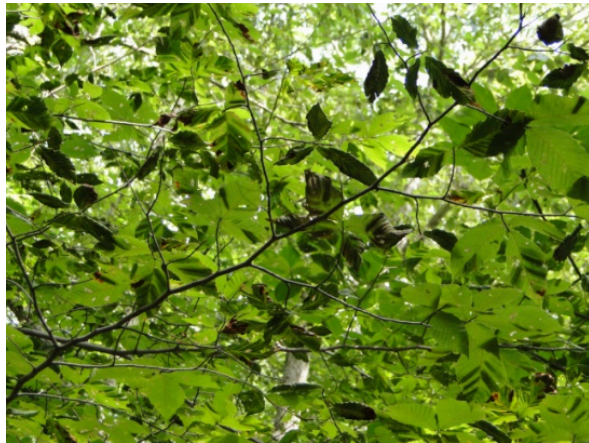
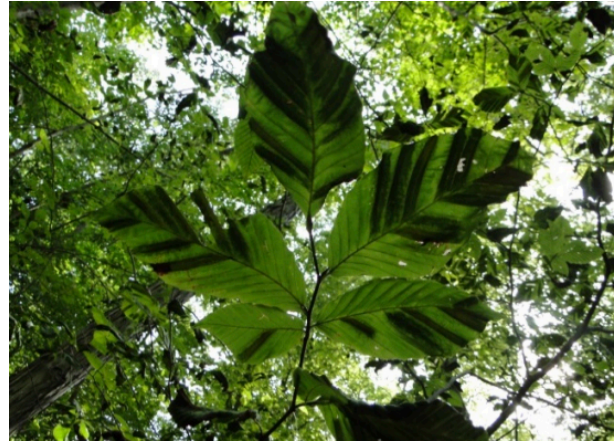
Beech leaf disease was first identified in Connecticut in 2019 and is present in landscaped areas as well as forests. A foliar nematode is found between the leaf veins causing dark interveinal patching visible from below the canopy in early spring with the leaf eventually turning brown leading to premature leaf drop. Trees will produce new foliage, leading to a reduction of root resources. Repeating annual cycles will lead to additional resource depletion. Trees, especially younger ones, can become more susceptible to other pests and pathogens resulting in death in 3 years.

Little is known about the invasive disease making management difficult. Vigilance through quarantines and regulations might be used to limit the spread. Pictures below left show telltale dark foliage due to nematode in leaf and right shows banding of interveinal habitation.

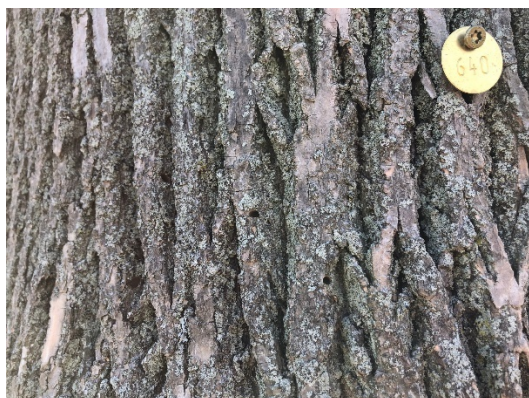
Figure 59 D-Shaped Exit Holes on Ash

EAB feeds on ash trees almost exclusively. While the larvae feed on the phloem and cambium, the adults feed on leaves. In Connecticut, there are three species of ash trees—the white ash (*Fraxinus americana*), the green or red ash (*F. pennsylvanica*), and the black ash (*F. nigra*). Despite its common name, mountain ash (*Sorbus* spp.) is not true ash and does not attract the EAB. Some inventoried species of green ash show some resistance in an otherwise infested area though it is too early to declare full resistance for the green ash population on the golf course campus.

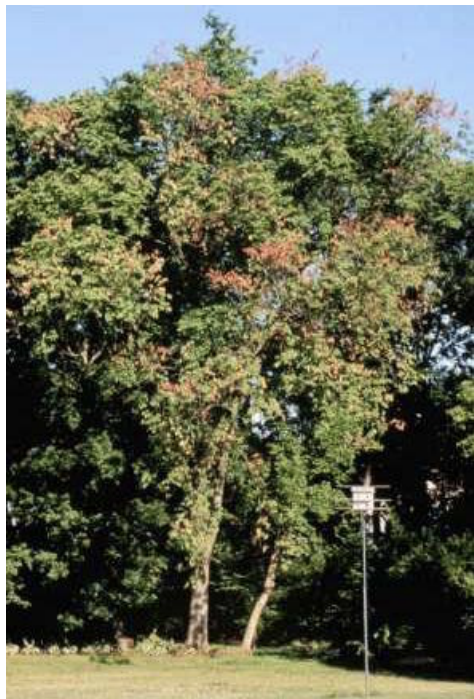
Figure 68 Flagging on Elm (note discolored foliage)

Dutch elm disease (*Ophiostoma ulmi* or *O. novo-ulmi*), a fungus, can occur on most elm trees and often on resistant varieties. The fungus is spread via elm bark beetles or by root grafts from adjacent trees. Symptoms develop quickly within a four- to five-week period, usually when the leaves have reached full size. The first visual symptom, usually seen within the crown of the tree, is referred to as "flagging." This occurs when one or more branches develop symptoms of wilting and/or yellowing of the leaves on an otherwise apparently healthy tree. Prior to this occurring, symptoms have developed internally and include the death of xylem cells, the loss of water-conducting ability, and the browning of the infected sapwood in narrow streaks that follow the wood grain channels. Dead branches begin to appear sporadically in parts of the crown. IPM scouting should also continue despite any fungicidal injections.

Eradicative pruning can slow the spread if there is enough clear wood between the infected area and the cut (five to 10 inches) (Northeastern Area State & Private Forestry USDA Forest Service (2020)).

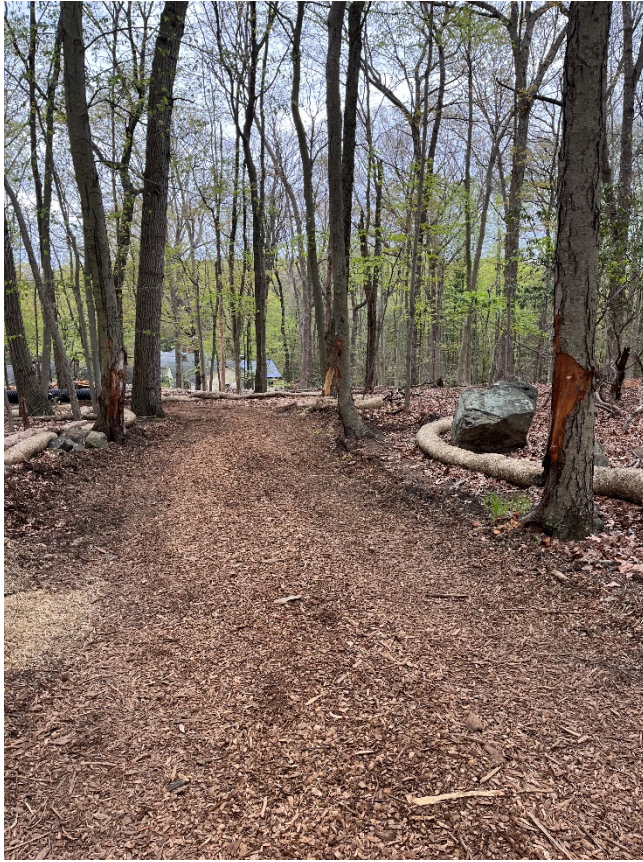
Figure 88 Trunk Scarring of Bark

Remaining trees, especially along forest and woodland edges or lone trees in managed lawn areas should be the focus of tree protection during construction and future monitoring efforts. Trunks that have been buried or scarred and roots that have been torn or cut with machinery, especially inside the CRZ, are more prone to bacterial and fungal root decay potentially leading to initial or delayed branch or tree failures. Clean hand sawn cuts of roots over 1" will ease compartmentalization of decay and bacteria. Stability threatening root and internal decay of trees is often difficult to diagnose and best prevented.

A six-month cyclical inspection is recommended for border trees found in woodland and forest areas, particularly those that have had cutting or filling activities within their CRZ. Foliage was not evident during the consultant's winter and early spring inventory.

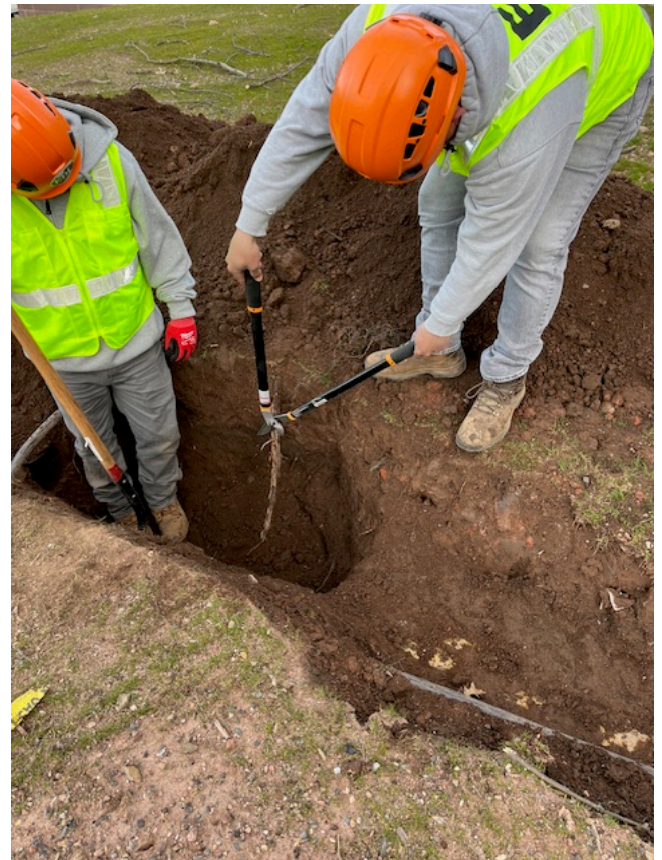
Figure 91 Workers Clean Cutting Roots in Trench

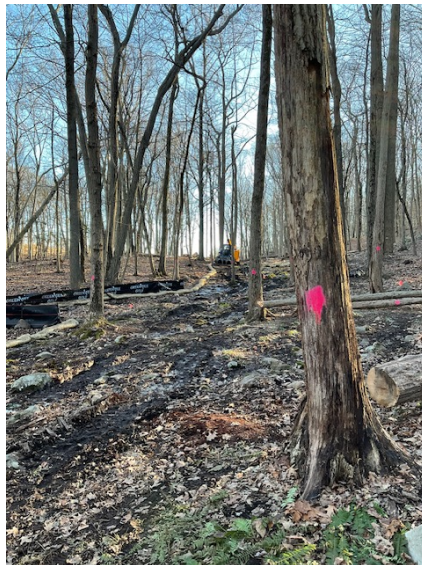
Figure 7 Tree marked for removal with pink spray paint

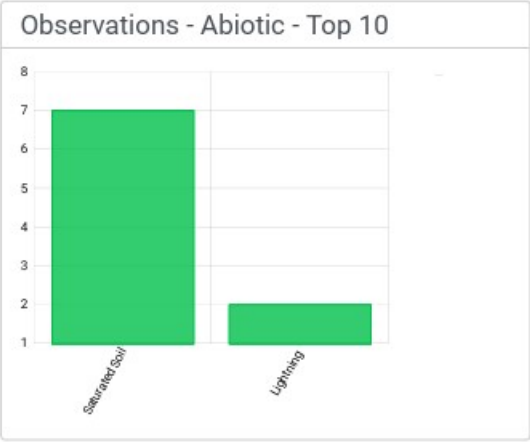
Abiotic observations were noted for some trees for preservation. These are maladies caused by non-living conditions (lightning, mechanical damage, etc.). Saturated soil was the most common with 7 trees observed under that condition and 2 trees with lightning damage. These trees haven’t been exposed to typical mechanical damage associated with abiotic disorders in managed areas such as mower or weedwhacker injury.

Figure 26 Abiotic observations and count

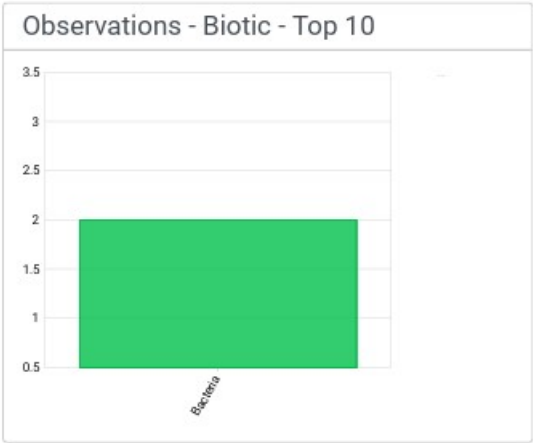
Biotic observations were made on 2 trees. These observations usually are more prevalent during active life stages of insects, fungus, or bacteria. Most of the signs of such living agents are more active and apparent during warmer seasons.

Figure 27 Biotic observations and count

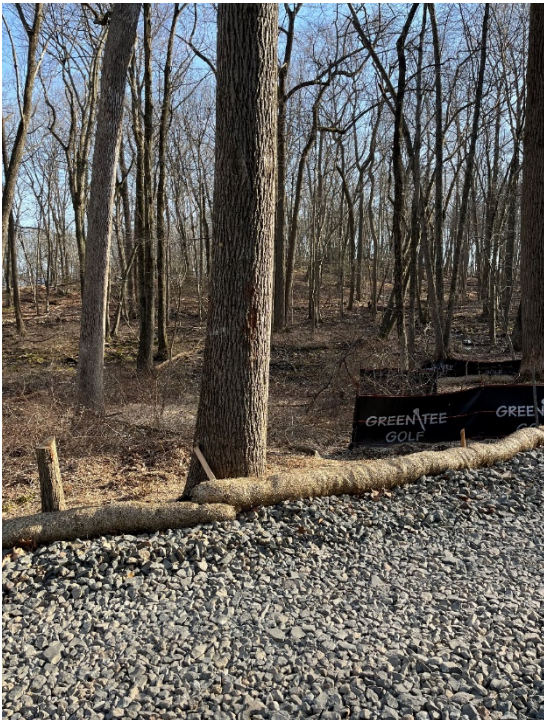
Figure 31 Exposed tree trunk needing protection on exposed on current haul road

Figure 29 Trunk protection concept for haul road trees falling within potential impact zone (approx. 4') (photo by C.Pepper 2018)

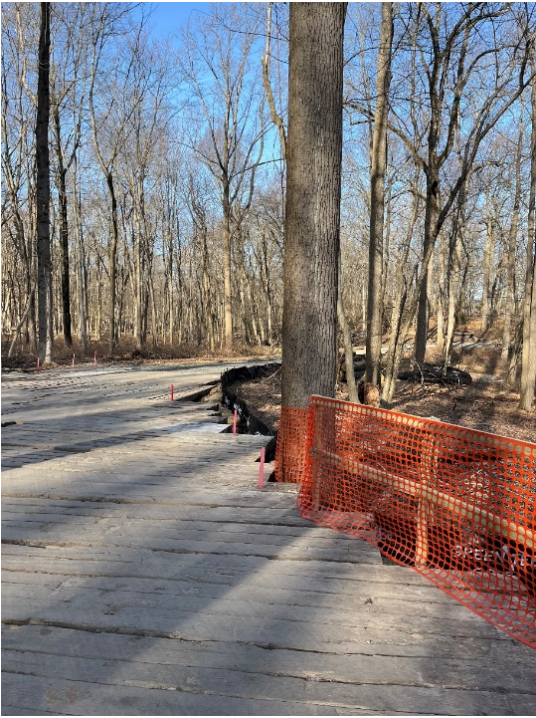
Figure 30 Tree trunk needing protection on current haul road
